Manhole Inspection Summary

Manhole # S01EE2036MH

Insp Date: **8/8/06 12:00 AM**

Location Address: **3301 Bancroft Rd** Cross Street: **Western Run Dr**

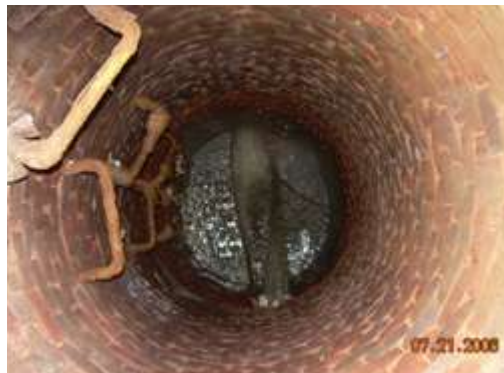
Top View

Chimney / Frame Adjustment ☒ Exists Material: **Brick** ☐ Parged Height: **6** (in.)
Condition: ☐ Sound ☐ Cracked ☐ Root Intrusion ☒ **Loose Brick** ☐ Deteriorated
Infiltration: ☐ None ☒ **Joint** ☐ Cracks ☒ **Mortar** ☐ Roots ☐ Wall

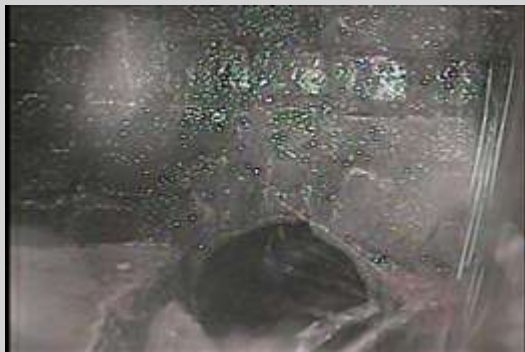
10 in. Circular Gravity Sewer Pipe Out @ 12 O'Clock

Pipe Material: **Clay** ☐ Pipe Lined

Invert Depth: **16.43** (ft.) Flow Characteristics: **Fast**

Deposits: ☒ None ☐ Mud ☐ Sludge ☐ Debris ☐ Grease

Infiltration: **None** Pipe Seal Cond: **Sound**

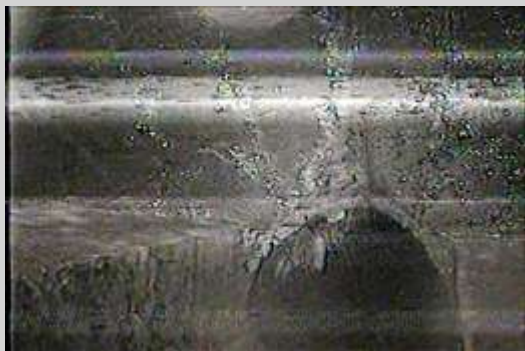
8 in. Circular Gravity Sewer Pipe In @ 3 O'Clock

Pipe Material: **Clay** ☐ Pipe Lined

Invert Depth: **16.20** (ft.) Flow Characteristics: **Fast**

Deposits: ☒ None ☐ Mud ☐ Sludge ☐ Debris ☐ Grease

Infiltration: **None** Pipe Seal Cond: **Sound**

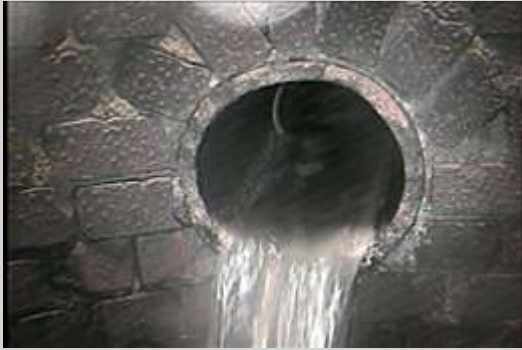
8 in. Circular Gravity Sewer

Infiltration: **None** Pipe Seal Cond: **Sound**
